WHY DID THE WATERPROOFING FAIL?

And How to Make Sure It Doesn't Happen to You

Session Description

This course evaluates the reasons that lead to failures of waterproofing installations. It examines product attributes that lead to successful installations and identifies the ways to identify necessary characteristics. Also compares installation methods and identifies ways to specify successful installations.

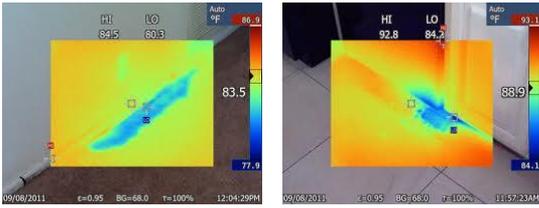
- Thermal Images of Shower Pan Leaks at Base

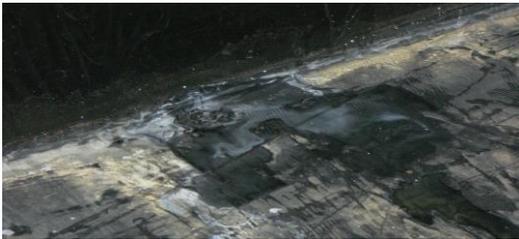
- Many Failures Occur at Pan/Wall Upturn

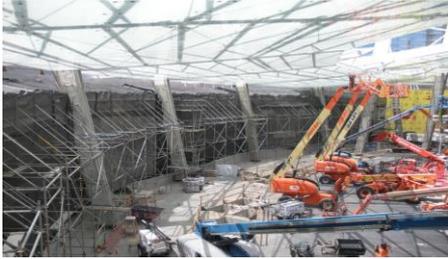
Exterior Applications often Demand Sheet Membranes for Primary WP

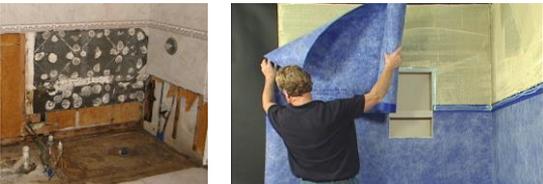
- Shower walls need low-perm WP membrane

A variety of products are available

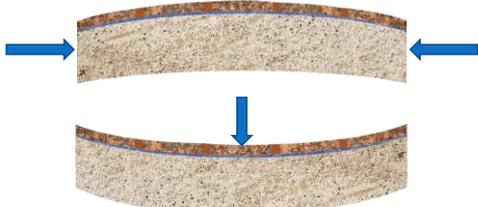
- Post Tension Pre-Stressed Concrete

Designed for Vertical, Horizontal & Lateral Movements

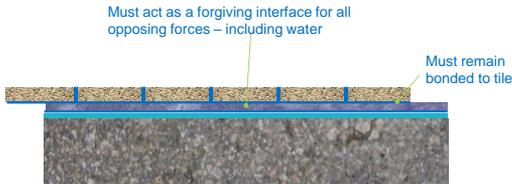
- (Indirect Bond)

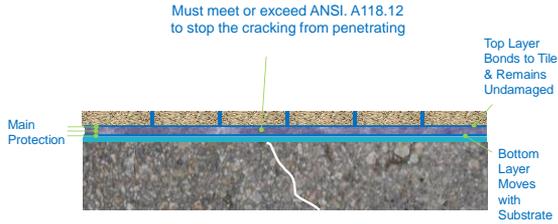
- (Indirect Bond/Composite Sheet Membrane)

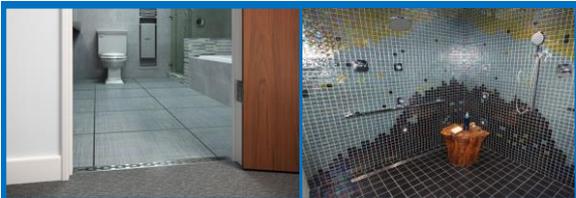
Linear Drains now integrate with waterproof membranes

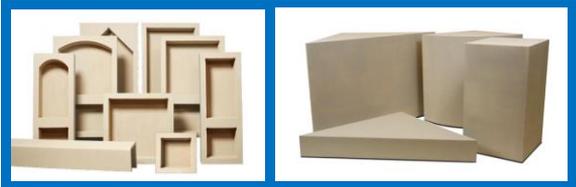
Waterproof pre-formed products are part of a successful waterproofing

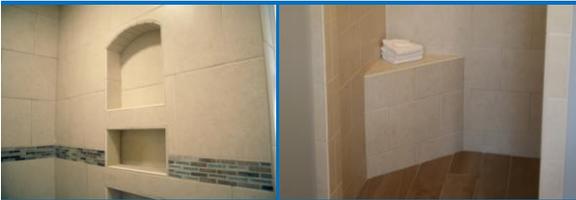
Waterproof pre-formed products are part of a successful waterproofing

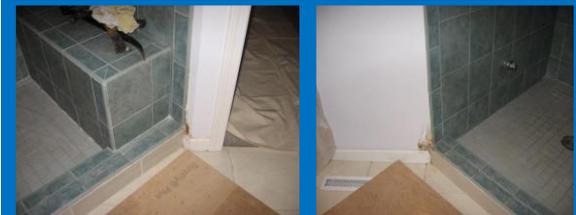
Waterproof pre-formed curbs eliminate failures like this!!

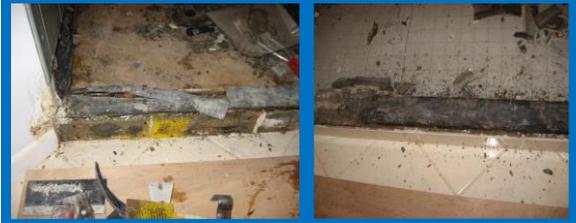
Waterproof pre-formed curbs eliminate failures like this!!

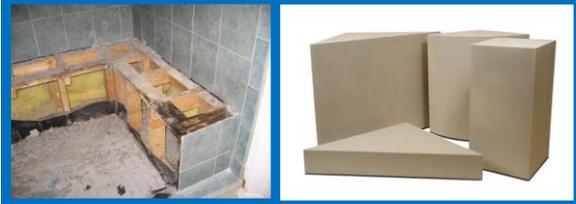
Waterproof foam benches are the solution

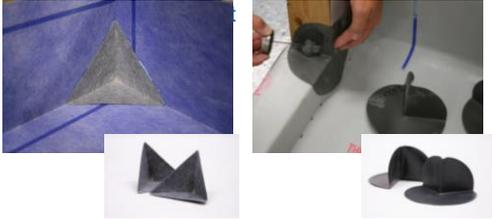
- Pre-fabricated inside and outside corners ensure the

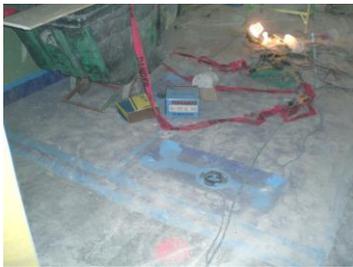
- Waterproofing is not a wearing surface
